DOT/FAA/AR-95/81

Corrosion of Aluminum Alloys in the Presence of Fire-Retardant Aircraft Interior Materials

Final Report

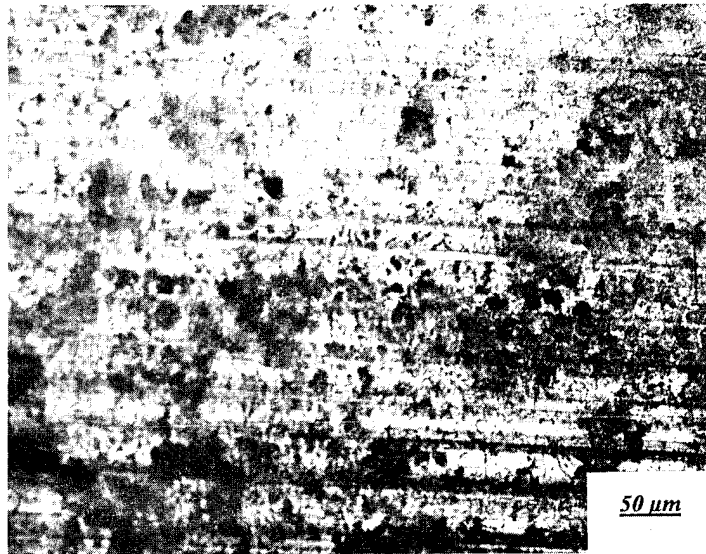
FIGURE 15. AL 2024-T3 WITH HIGHLAND WOOL, 70°F, 90% RH, 7 DAYS
(40 POINTS)

Typical optical micrographs for specimens in each category are presented in figures 7 through 16. Cross sections were cut from the samples and optical micrography was performed where the depth of pitting was the greatest. Figures 17 to 22 present selected cross-sectional micrographs.
